Royal Red Cliffs Golf Club

The story of the new Bar

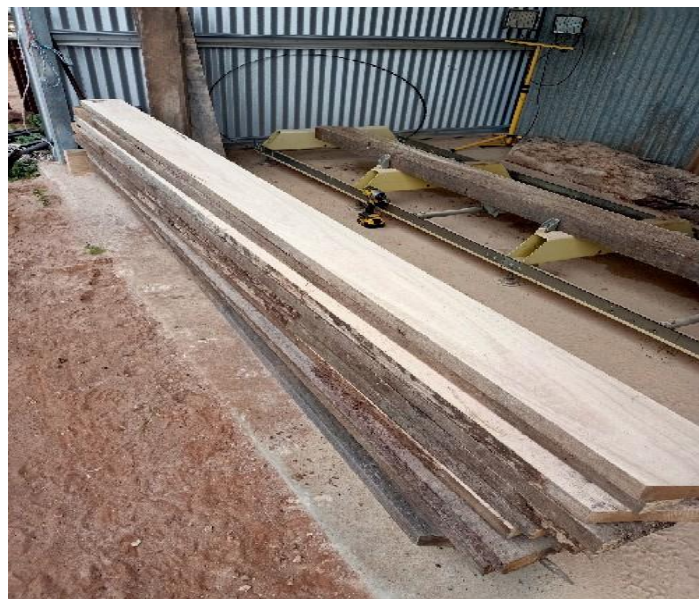
Posts having been made into planks to the right is the milling machine (can see white ant damage along the edges of planks)

The next step of this project. To find someone who could mill (cut) the posts into 50mm x 200mm slabs (planks) of timber. It turned out to be a long exercise as a special type of band saw is required. Both Tom and I knew one person whom I contacted and was very helpful over the phone but an attempt to meet him did not eventuate so after about the 4th attempt, we started looking elsewhere. A member of the golf club whose name fails me (my apology) put me in touch with Blueys Tree and Stump removal (Anthoney Pay) so I loaded up my trailer with the posts and took them to his yard in Merbein South I put Bluey in the picture as to what we were going to attempt with the timber and to save my pride a little bit in what the hell I was I doing with white ant damage timber. Bluey was very understanding and said he would do it for \$100,00 (this was on the **11/09/2022**)

After a few days. Bluey called to say he had finish cutting the posts into planks, I went and picked them up and took them back to my workshop. The timbers were quite moist where they had been sawn as the band saw blades have to have water running over them when cutting. I set up a tent like structure over the stack of planks on carpenter stools and with spacers between each layer of planks. This was to help dry out the timbers, so they did not warp/twist and bow too much. Every few days I turned each plank over so as to equal out the drying process of each plank, this took a few weeks (the tent structure was a tarp which hung over the top and down the sides but allowed air flow under the tarp and around the planks)

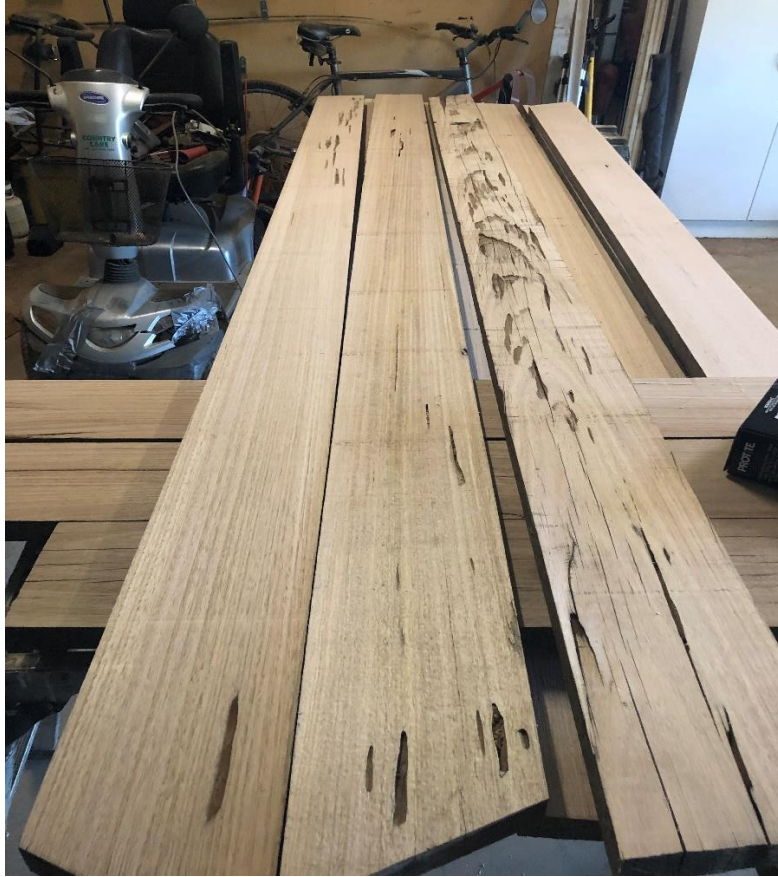
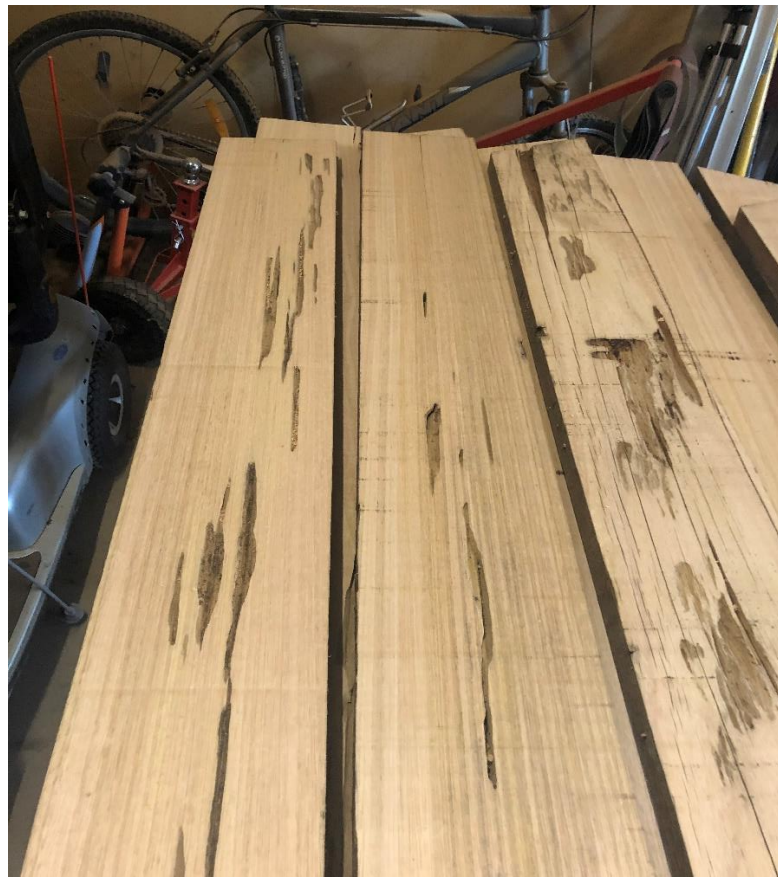
White ant damage timber planks after being dressed.

Next step was to dress each plank. The band saw blade cut was not quite true and gave the planks a small wedge shape look, One edge was a bout 40mm the opposite edge was about 50mm in a 200mm width, I used a table planer (electric) to dress each side of the planks (face sides) This took a considerable amount of time as each face had to done 4 to 6 times which equals 12 times through the planner per board and there are 12 full length boards in total, each being 4 metres long.

Next step was to true up the planks (straighten) as some of them were bowed, and at the same time square the edges with the face of the planks. I straightened one side of each plank and then ran the other edge through a table saw, then dressed each edge.

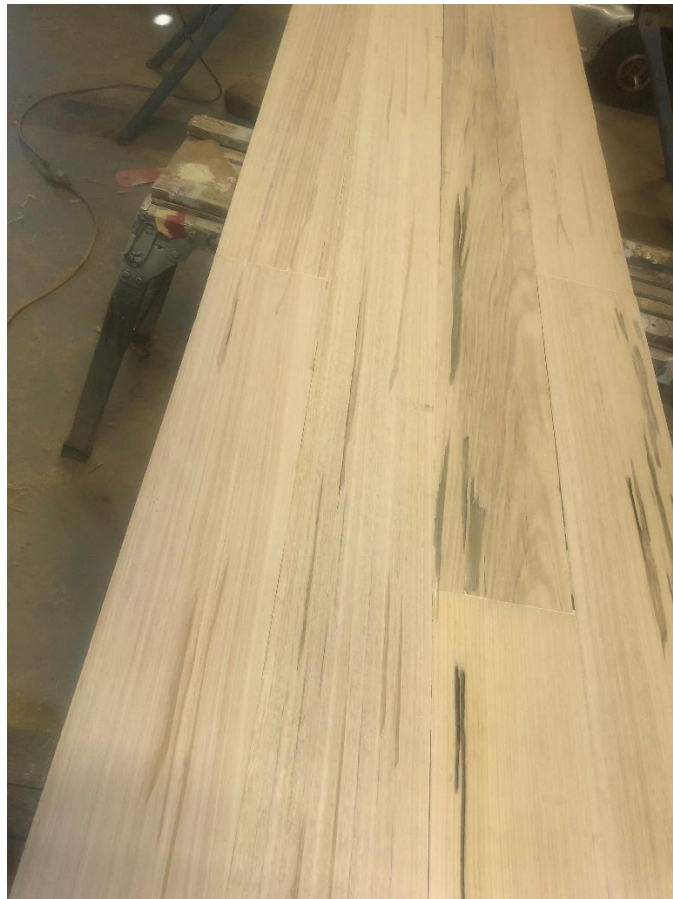
After a few weeks clamps removed and board cleaned up with hand cabinet scraper.

Next step was to prepare the bar top surface which was mainly done by hand using a hand cabinet scraper/shaver tool and sandpaper, this was to try and keep the surface rustic looking/oldy worldly. Then using a resin with a black dye, I literally injected into the sap veins/tracks left by the white ants. This again was left to dry out completely over a few days. The resin expanded as it dried and had to be again box scraped to level it off with the timber tops surface.

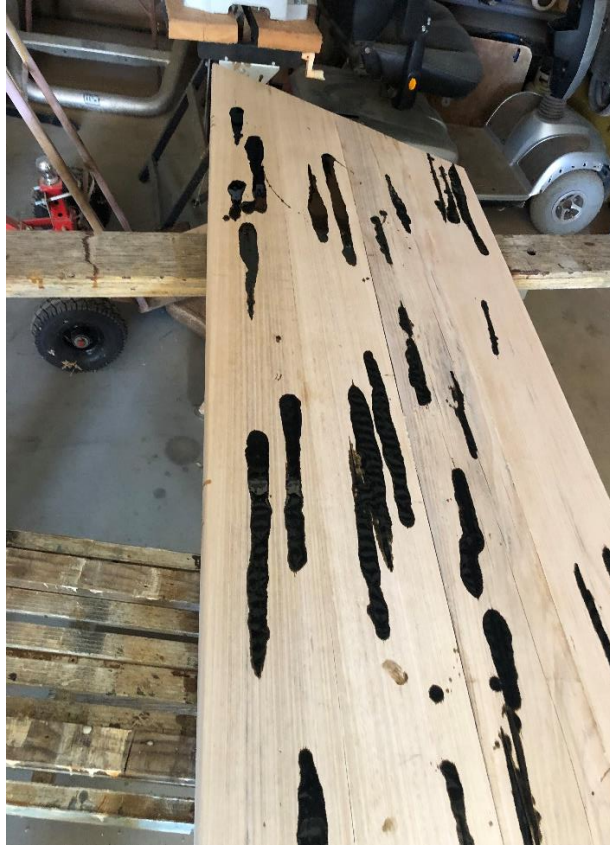
Black dye mixed with resin then injected into white ant tracks in the bar tops.

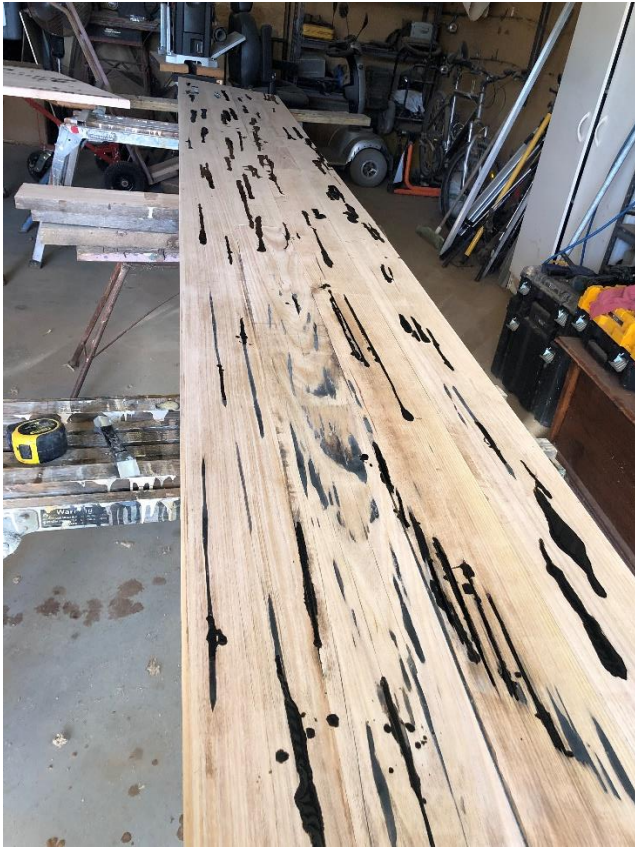
The black dye expanded as it dried out.

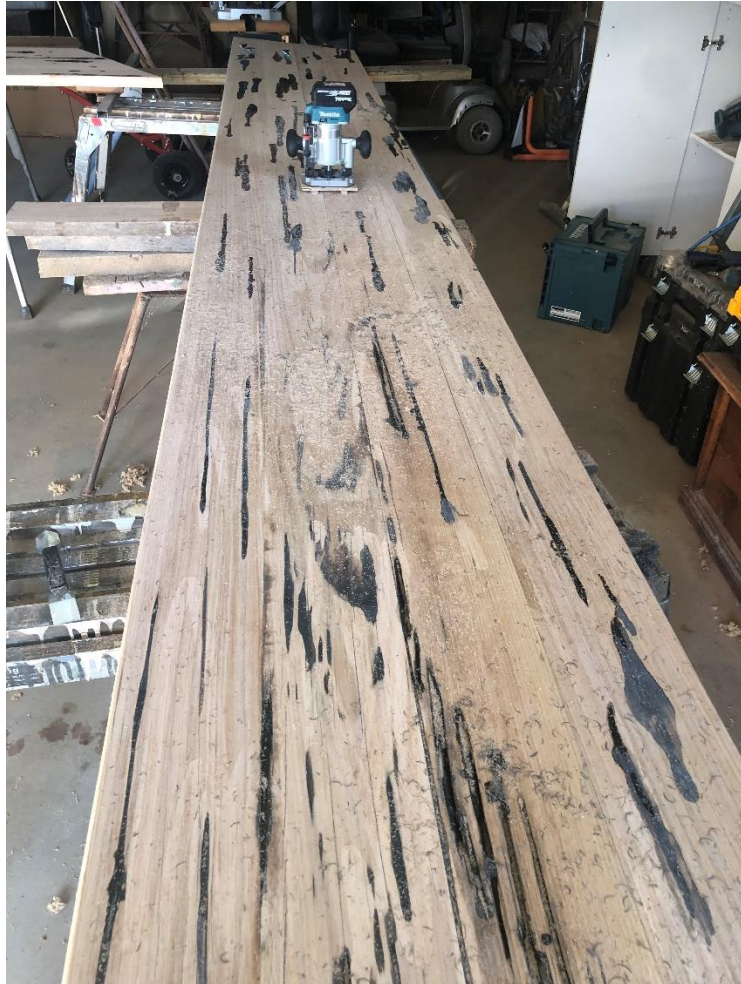
Leveling the black dye back to the timber top surface

I then put one coat of clear resin over the complete tops to seal the timber and protect the surface when the top is installed. It will need more coats after installation.
